Weekly Review

Date: 6/30/23
To: USDA, SWI-Ardurra, Fann
Re: Wellsite 4 progress
Sender: Jan Tijmes

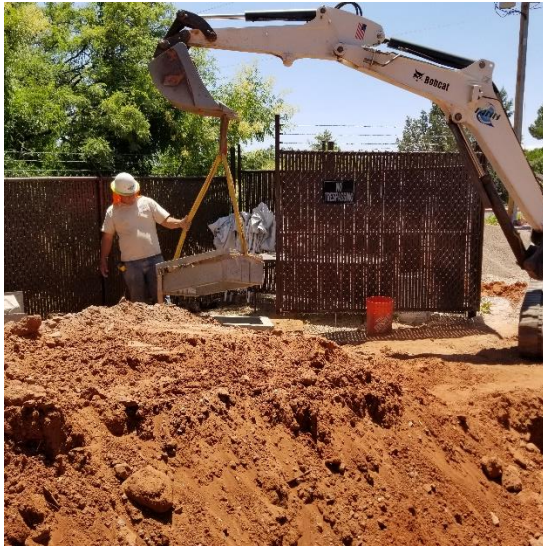
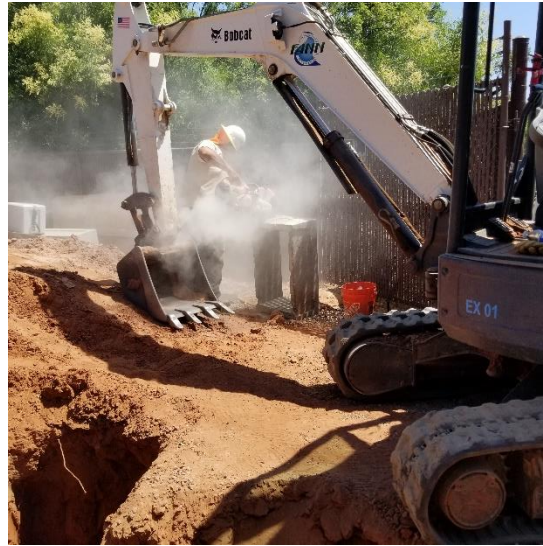
6/26/23

Fann (Jim and Juan) worked at Wellsite 4 this week cutting and installing valve boxes. Still no news on the 60" manhole which covers the butterfly valve.

The quality of 'Caution' Detectable Tape, which is installed about 12" above the waterpipe in the trench, was discussed. It was agreed that within the wellsite fencing, the light-duty tape may be utilized. Outside the fencing and in the ROW, the heavy-duty aluminum tape should be used.

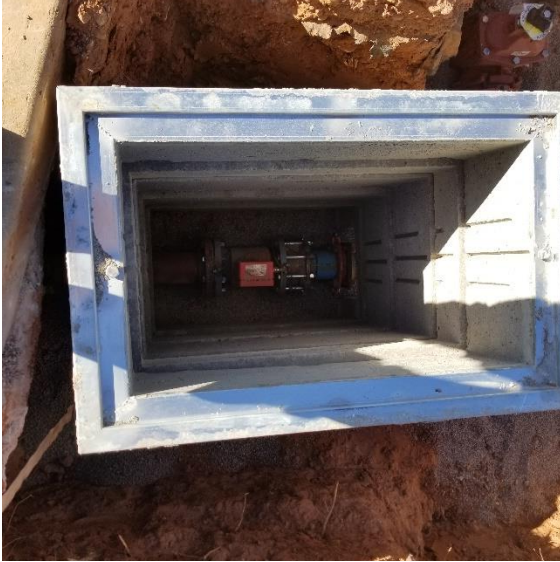
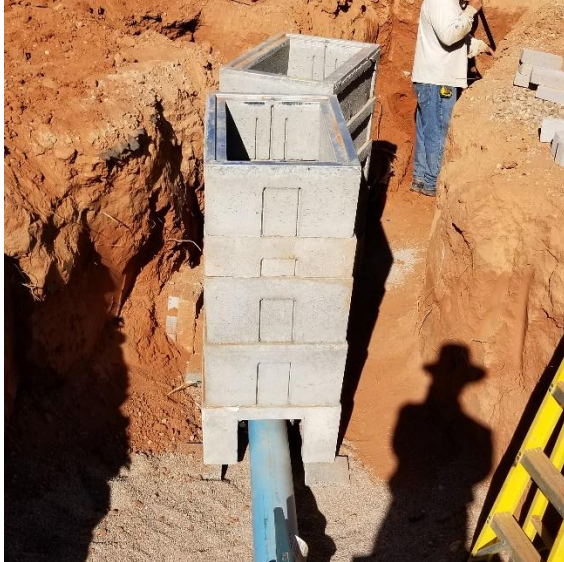
6/27/23

Fann Crew continues to install valve boxes. Their next task is to install the yard hydrant with saddle tap on the west side of the wellsite and the check valve coming off the treated water line from the arsenic filters on the east side.

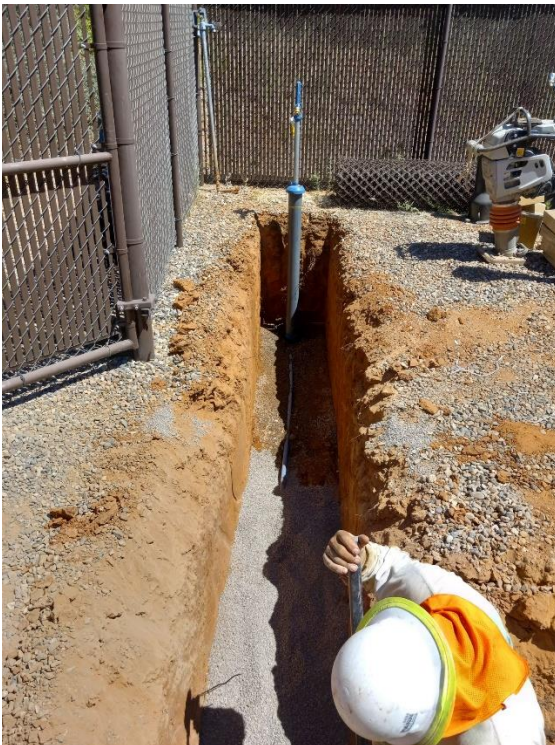
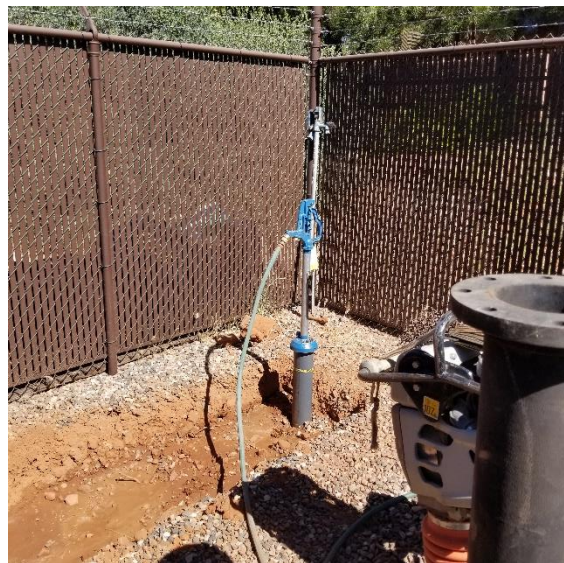
6/28/23

Jim and Juan (Fann) continue to install valve boxes. The yard hydrant was installed in the NW corner of the wellsite as opposed to the SW corner in order to avoid electrical lines and be away from a gate opening. It was installed 5ft from the static mixer to provide a well-mixed sample during sampling events.

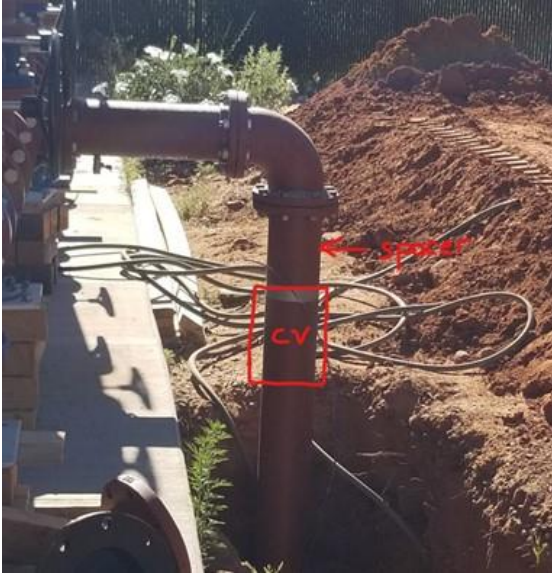
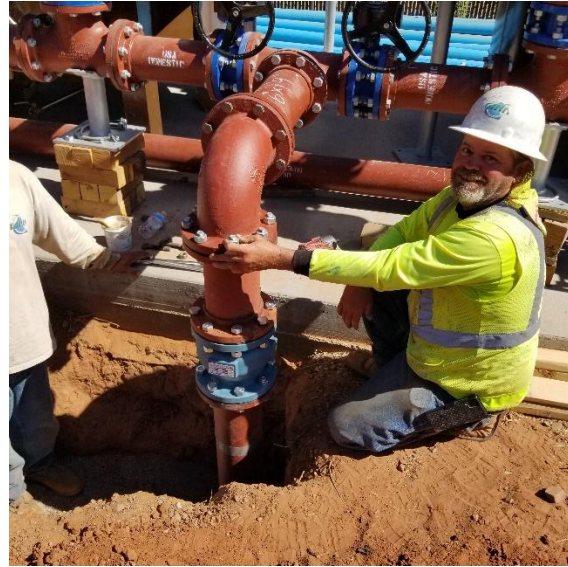
I spoke with Valmatic to discuss spacing between bends and their globe-style check valves. It was recommended that a minimum of a width of the check valve up to 3D should be used as a spacer between the 90° bend and the check to increase longevity of check with uniform flow across the disc. A 12” spacer was chosen.

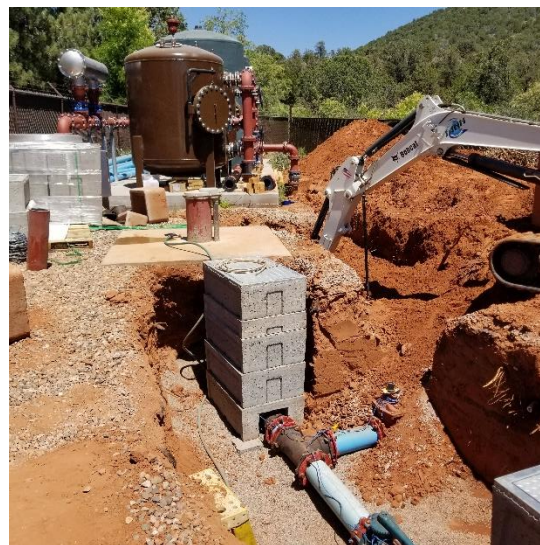
6/29/23

Check valve was installed today with Jim and Juan from Fann. Michael, Fann’s electrical team, arrived to the site to review power and conduit from the main panel to the arsenic treatment system. He will begin installing and connecting power next week. Fann continued to excavate the treated and raw water lines from the arsenic filters to the newly installed distribution line to begin tying in those two legs of the system.
